Immersive Witness Interview (IWI) - Reconstruction, Cave Creek, AZ USA

Immersive Witness Interview (IWI[®])
Accident: EC135 T2, S/N: 0094; N127TS; Services Group of America;
Cave Creek, AZ; 02-14-2010; NTSB Ref: WPR10FA133

In the frame of the Cave Creek accident investigation, five witnesses were interviewed on April 19-20, 2011 with the Immersive Witness Interview (IWI®) method. These interviews were conducted by Dr. Bauer and the NTSB investigation team more than a year after the accident. The main objective of the study was to demonstrate the IWI technology to the NTSB.

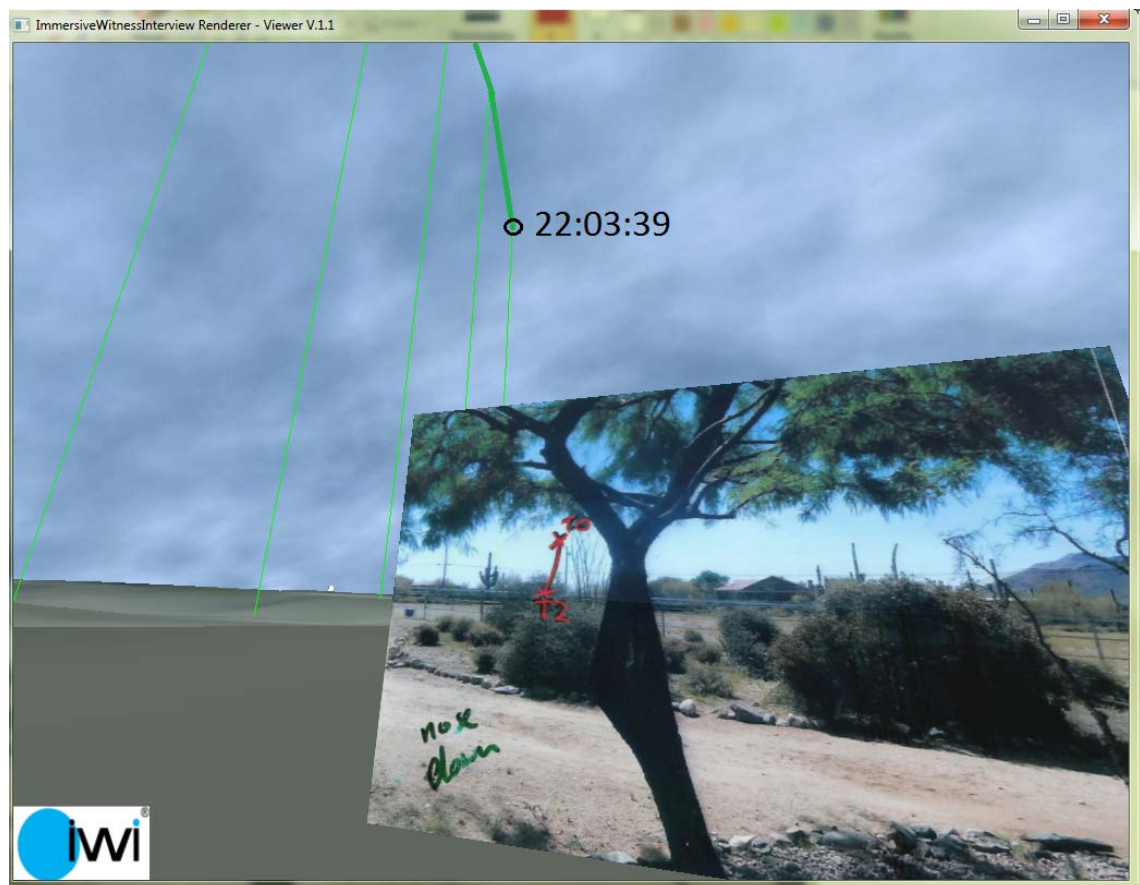
The witness #1 was inside his house when he heard the helicopter over his house. He heard a “pop pop” sound and went to the window. Figure 2 shows the witness’s South view out of the window, when he first saw the helicopter, with the nose down and falling from the approximate positions indicated by points T0 to T2 (red line). The green line at the top of the image is the radar plot, which depicts the helicopter’s flight path coming from the north flying over the witness.

Figure 2: Radar plot (green) and photo of witness #1’s view with his observed flight path (red line between points T0 and T2)

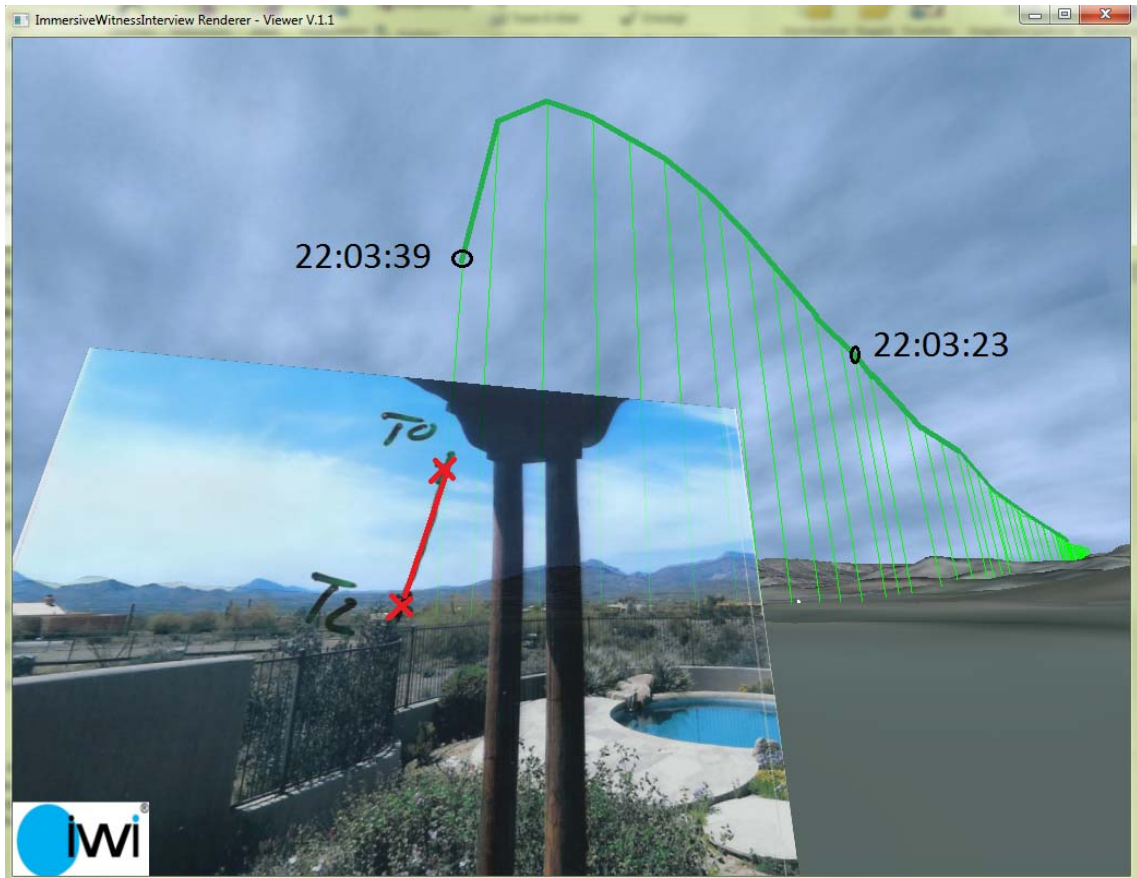
The witness #2 was inside his house when he first heard the helicopter. He heard a strange sound and went outside to his terrace to see. As shown in figure 3, he saw the helicopter falling down (red line) from the approximate positions indicated by points T0 to T2. The green line at the top of the image is the radar plot, which depicts the helicopter's flight path traveling from the right to left.

Figure 3: Radar plot (green line with vertical lines) and photo displaying the view from witness #2 with his observed flight path (red line between points T0 and T2)

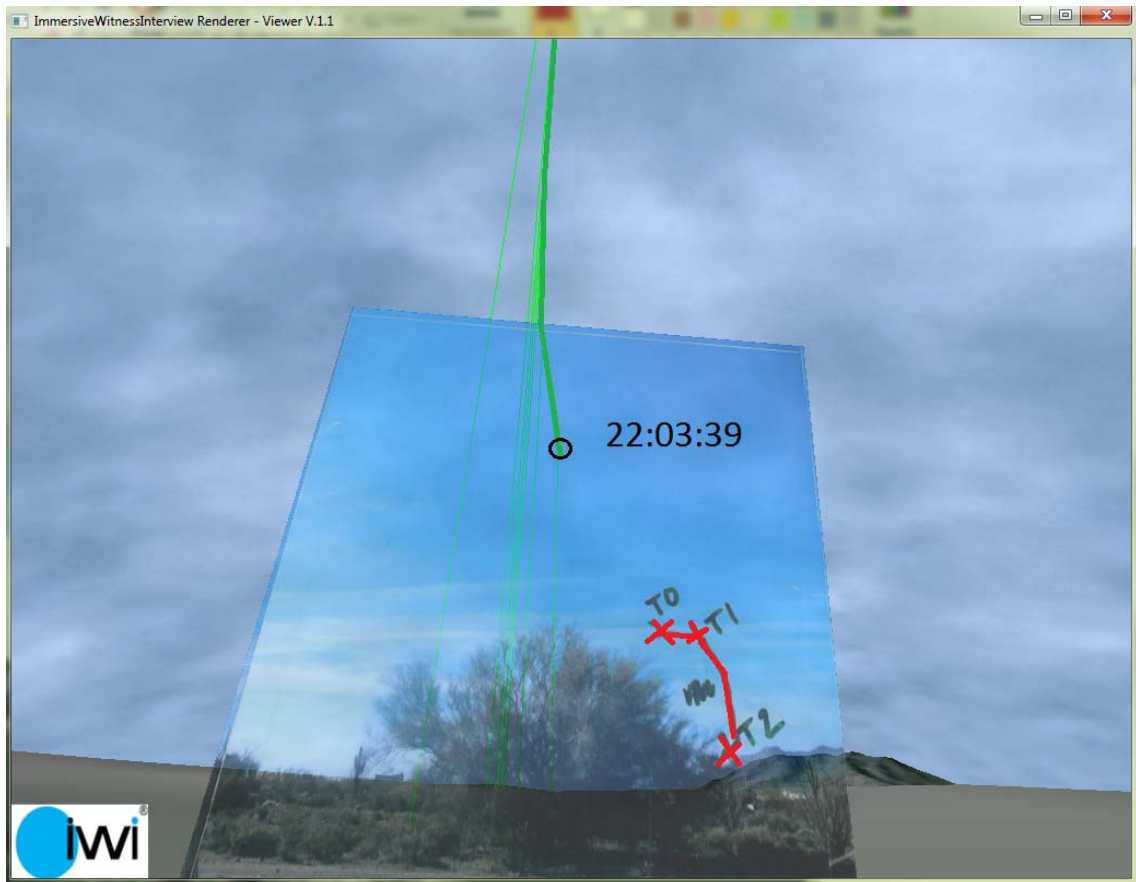
Witness #3 was in the front of his house when he first heard the helicopter flying overhead. He then heard an unusual “pop pop” sound and then looked up and first saw the helicopter at the position approximately depicted by point T0 as shown in figure 4. The red line shows what the witness believes he observed the helicopter’s flight path to have been between the points T0 to T1 and then going down to T2. The green line at the top of the image is the radar plot, which depicts the helicopter’s flight path flying over the witness towards the south.

Figure 4: Radar plot (green line) and photo depicting witness #3's view and observed helicopter flight path (red line) from T0 to T1 to T2

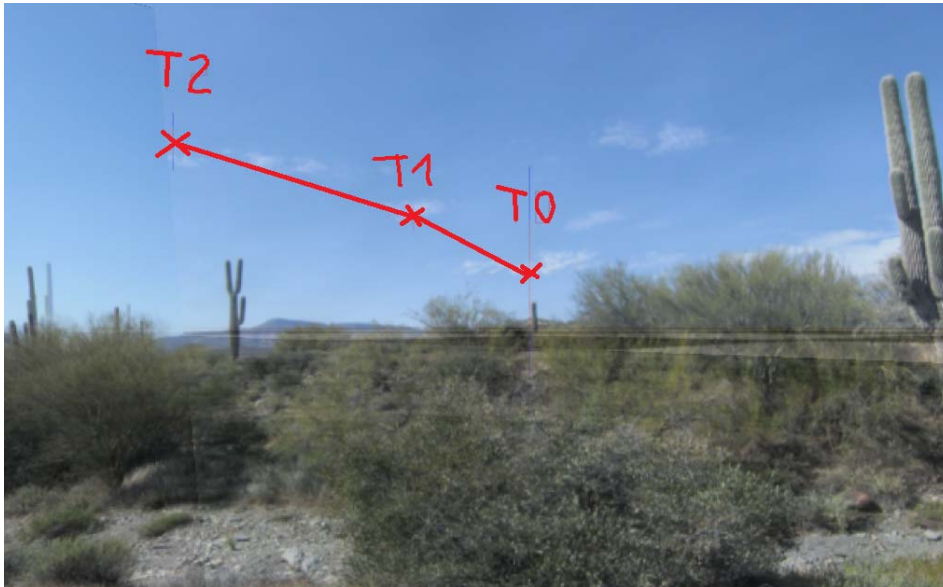
Witness #4 was walking his dog in a lower terrain area of a creek bed when he first heard the sound of the helicopter. Figure 5 depicts the location at which he first saw the helicopter at T0 traveling towards him from over the hills north of his position. At T1 he described hearing a “pop pop” sound and saw pieces falling off the helicopter. He stated that the helicopter then started to descend to the location depicted at point T2.

Figure 5: Witness #4's view (from the creek bed) with his observed helicopter flight path (red line) from T0 to T1 to T2, flight path as depicted by radar is out of view to the right.

Witness #4 was generally below the helicopter and began to move to a higher elevation, looking up to observe the helicopter. This is a challenging perspective for a witness from the standpoint that the witness had limited reference objects which changed over time as he moved.

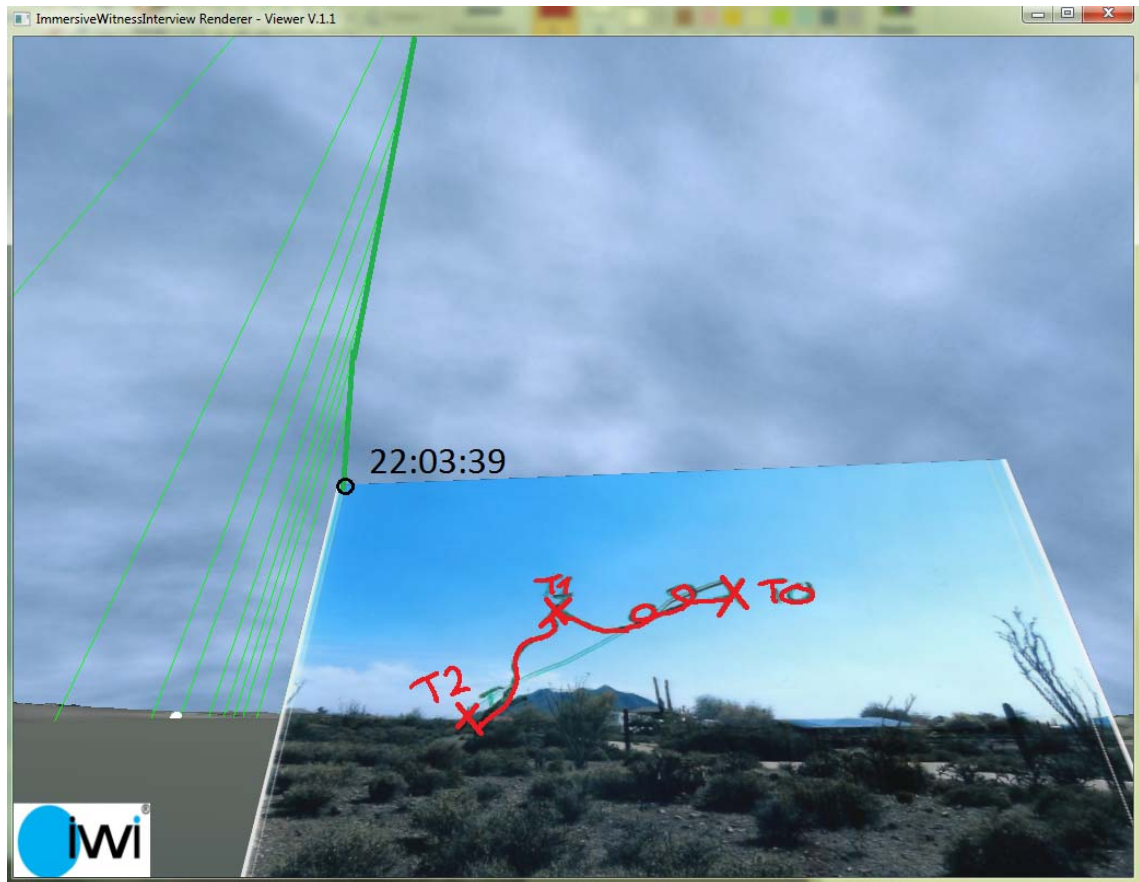
Witness #4 then moved out of the low creek area to a higher position approximately 70 feet from his initial location (figure 6), where he saw the helicopter again, and this time beginning at a point marked by T0. At this point the witness stated that the helicopter was “going down, and rotating twice, then going up a bit and falling over”. This is depicted in the moments of traveling between points T0 and T1; he then described it going down to the point marked by T2.

Figure 6: View of witness #4 (above the creek bed) with his observed helicopter flight path (red line) from T0 to T1 to T2

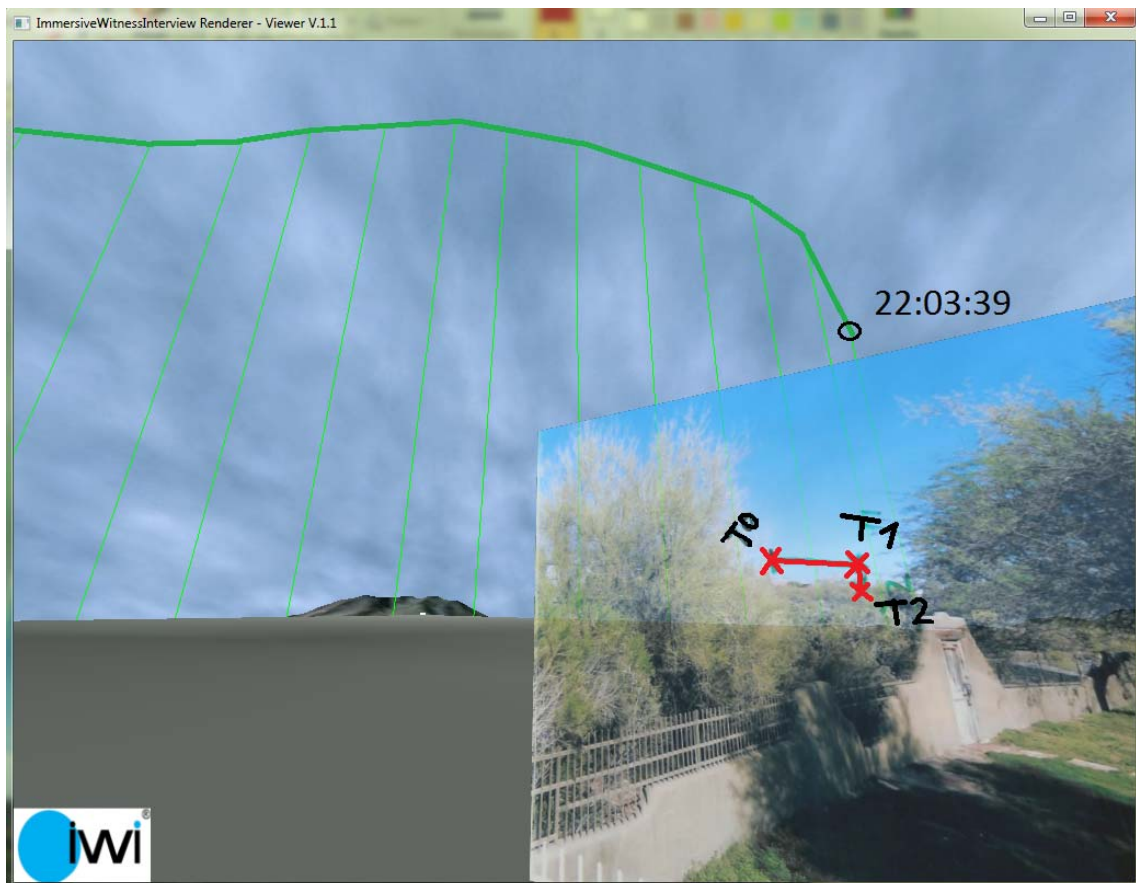
During the IWI interview, more than a year after the accident, the witness explained that he was in his backyard when he initially heard the helicopter. After hearing a strange sound which he described as a “big bang” he went next to the pool and looked over the fence (see the photo in the lower right of figure 7). The witness stated he saw the helicopter for the first time at the approximate point depicted by T0 (coming from the left out of the trees in his view). Then at T1, he noted that the helicopter began to go down to T2. Figure 7 also shows the radar flight path data depicted by the green line, showing the helicopter traveling from the left within about 1,800 feet above ground level. The witness described the flight path of the helicopter much lower.

Figure 7: Radar plot (green line) and photo of witness #5's view (lower right) with his observed helicopter path (red line) from T0 to T1 to T2

Witness #5 reported the altitude of the helicopter's flight prior to the accident sequence to be generally lower than what was recorded by radar. As it would have taken the witness several seconds after the "pop pop" sound to move to his vantage point, it is unclear at which point during the flight path he observed the helicopter.

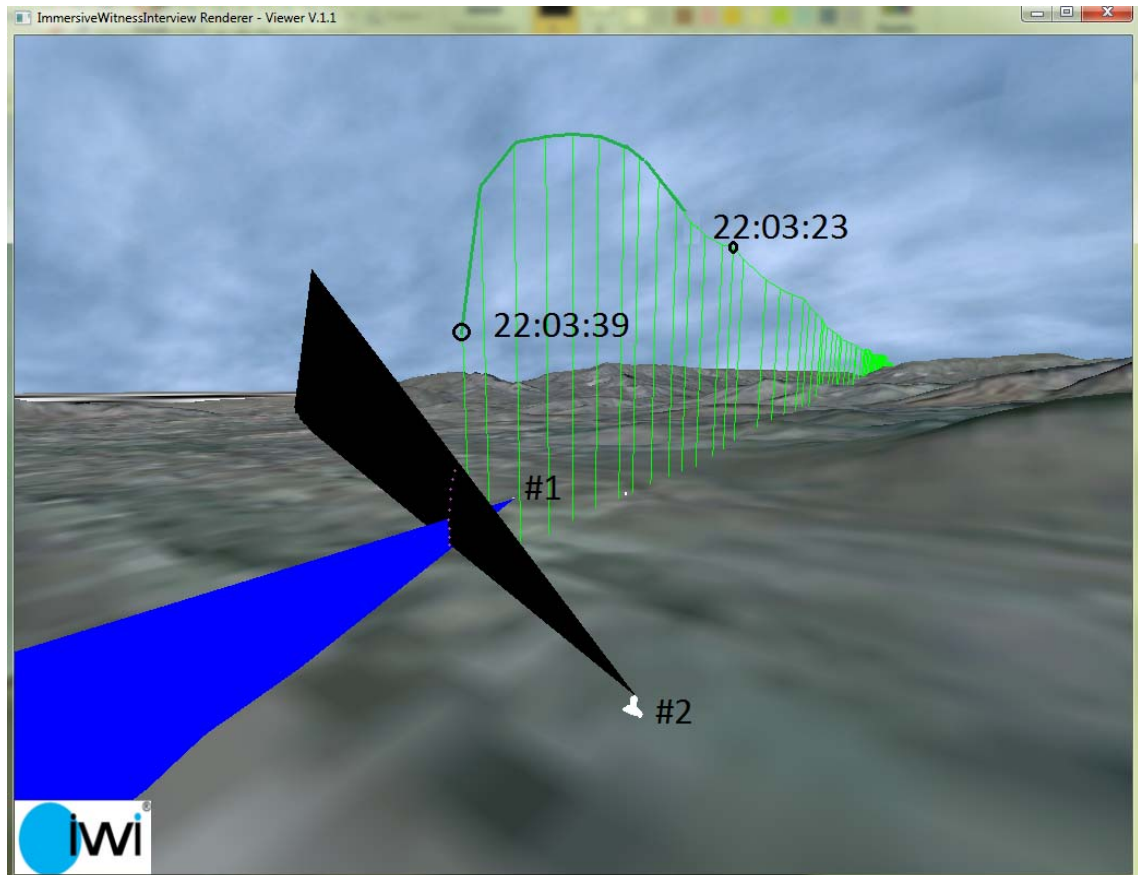
The radar data did not include the end of the helicopter's flight path to the accident site. Figure 8 shows the lines of sight for Witnesses #1 and #2. If the intersections of both lines of sight are considered, then an almost vertical flight path can be expected (shown in figure 8 with a purple dashed line). Based on the observations of witnesses #1 and #2, the helicopter's flight path just before impact was almost straight down.

Figure 8: Lines of sight of witnesses #1 (blue shading) and #2 (black shading), the assumed final flight path (purple line), and the flight path based on radar data (Green)

Based on witnesses #1 and #2, the ground impact position of the helicopter was calculated to be at: Latitude: 33.84811215° and Longitude: -111.92505423° . This reconstructed point is quite accurate, as it is only about 75 feet away from the actual position of the helicopter wreckage.

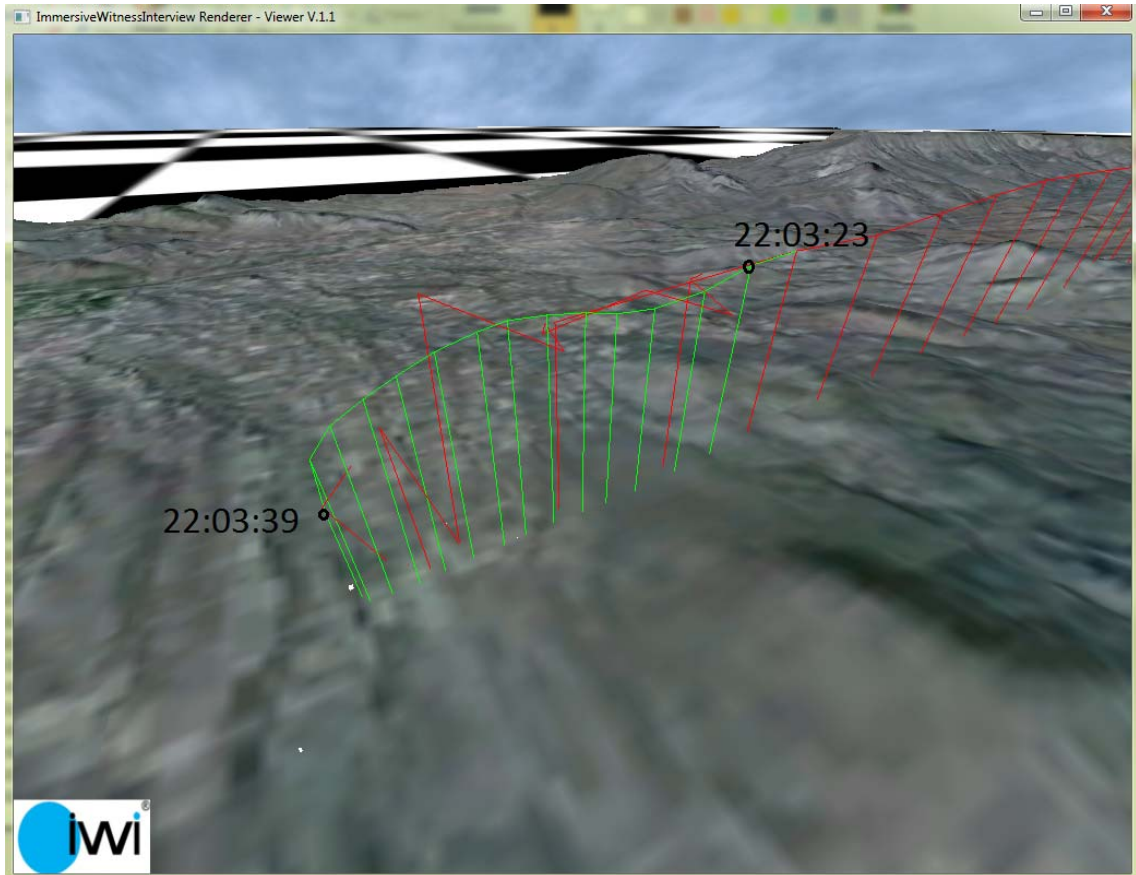
The following tables show the provided radar data. Radar data points 3-16 have been interpolated as shown in figure 9.

Point 17 shows the crash site and the altitude values for points 11, 13 and 14 were interpolated due to radar only (RO) and beacon only (BO) returns for these points (no altitude info available).

Figure 9: Radar data (red) with interpolated data at the end (green)
